CUYAHOGA VALLEY NATIONAL PARK
Programmatic Environmental Assessment for Riverbank Management
of the Cuyahoga River

Appendix I

**Supplemental Detail and Description of Conditions:
Riverbank Management Alternative**

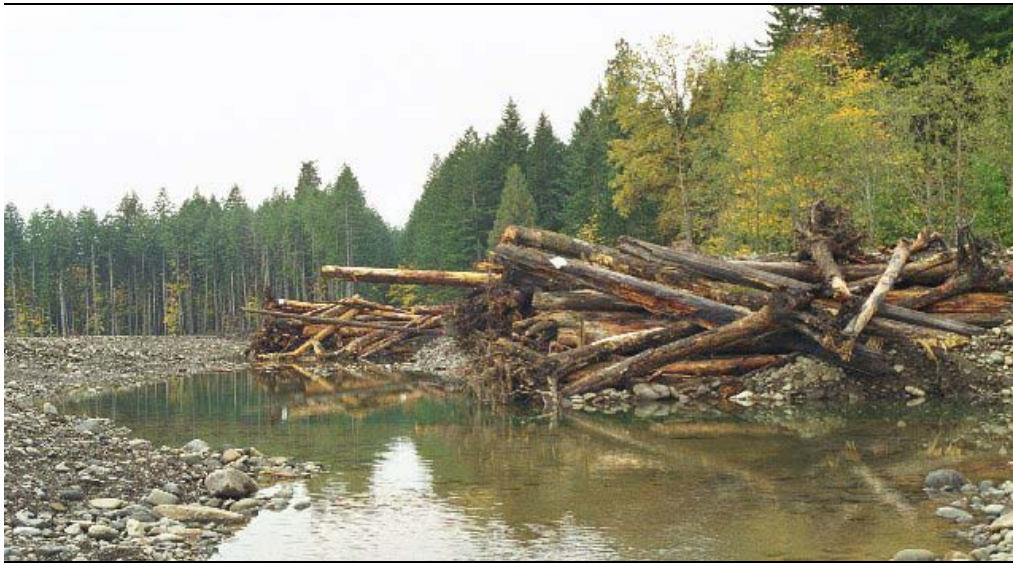
Figure I-7. Engineered Log Jam (U.S. Forest Service).

Engineered log jams use natural structures that emulate natural riverine processes to protect roadways adjacent or parallel to river channels. Engineered log jams are usually placed in series, in combinations, or in pre-selected channel reaches. Log jam structures can: (1) stabilize channel banks and protect roads using native materials, (2) deflect and catch large woody debris in transport, (3) promote establishment of vegetated riparian areas (channel banks and in-channel riparian islands), (4) improve or create new fish habitats, and (5) restore or maintain the aesthetic or natural character of the river. The construction of engineered log jams require the following detailed site and survey information: channel longitudinal profile, pool survey, wood survey and, channel bottom pebble counts. Additional information includes channel hydraulic and scour analyses, along with a geomorphic analysis to formulate site design. Figure I-6 shows an example design concept for an engineered log jam, and Figure I-7 is a photograph of a completed engineered log jam.

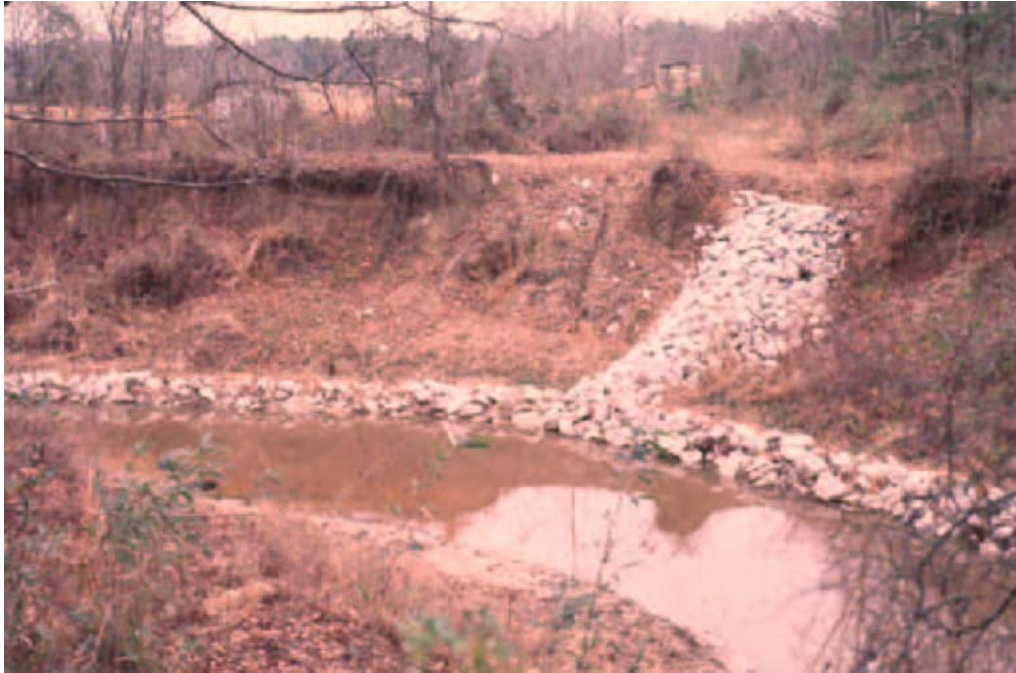
Figure I-9. Longitudinal Peaked Stone Fill Protection (LPSFP) (Biedenharn et al, 1997).

Longitudinal Peaked Stone Toe Protection (LPSTP) is a continuous, triangular shaped stone dike placed longitudinally at, or slightly streamward of the toe of an eroding bank. It typically utilizes 1 to 2 tons of rock per linear foot and varies based upon the depth of scour at the toe, estimated stream forces on the bank, and flood durations and stages. Longitudinal Peaked Stone Toe Protection must be keyed into the bank at both the upstream and downstream ends of the protection. Tiebacks are intermediate stone features that connect the LPSTP to the bank at regular intervals, and are the same height as the LPSTP or elevated slightly towards the bank end and are keyed into the bank. Long tiebacks should be angled upstream to act as bendway weirs. Figure I-9 shows an LPSTP installation. A more complete discussion of the design of LPSTP may be found in *The WES Stream Investigation and Streambank Stabilization Handbook* (Biedenbarn et al, 1997).

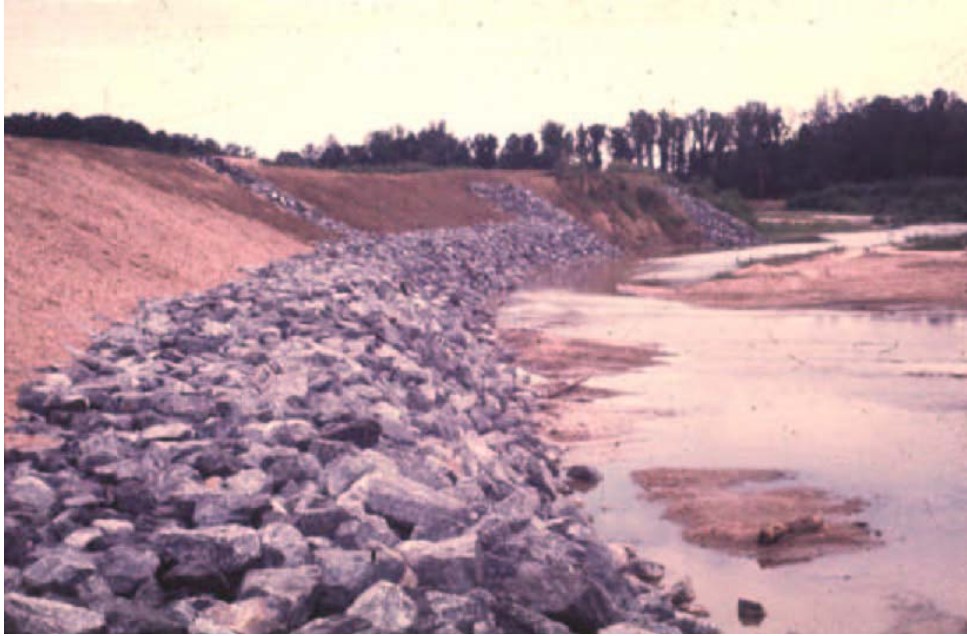
Figure I-10. Longitudinal Fill Stone Toe Protection (LFSTP) (Biedenharn et al, 1997).

Longitudinal Fill Stone Toe Protection (LFSTP) is similar to LPSTP, except that instead of coming to a peak, the crest has a specified width. Therefore, LFSTP has a trapezoidal cross section rather than a triangular cross section. In areas of deep scour, LFSTP provides sufficient rock to self adjust, or launch into the scour hole, while still maintaining its original crest height. An example LFSTP is shown in Figure I-10. A more complete discussion of the design of LFSTP may be found in *The WES Stream Investigation and Streambank Stabilization Handbook* (Biedenharn et al, 1997).

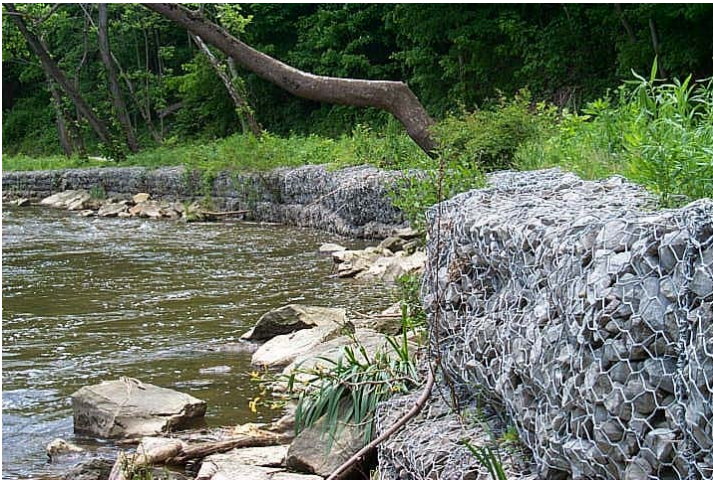
Figure I-11. Stacked Gabions at CVNP.

Stacked gabions, as shown in Figure I-11, have been used in several areas adjacent to the Towpath Trail. Gabions are rock-filled wire or synthetic baskets that are wired together to form continuous structures. The mesh is typically galvanized or coated with polyvinyl chloride to reduce corrosion. Gabions can use lower quality stone than riprap structures and can be placed on steeper slopes. Gabion structures are flexible enough not to be vulnerable to minor bank shifts but need to be placed on a firm foundation. Gabions may also be used to construct deflective structures, and

would have the same impacts as jetties or hardpoints when constructed as such. Sediment is usually deposited among the rocks in gabion structures, and vegetation often becomes established so that the structure is obscured and the stream has a natural appearance. Unvegetated gabions are similar in appearance to masonry work, which may be visually pleasing in some settings. The steep slopes on which gabions are sometimes placed may hinder wildlife access. Gabion structures can be designed with artificial overhangs, flow deflectors, and other features to enhance fish habitat. Failed baskets may be hazardous to recreationists, especially canoeists. Gabions have been widely used for streambank protection on streams located in a variety of environments in the US and Europe. They are most frequently used in urban areas, particularly on small watersheds where high flood conveyance is desired. Gabion streambank protection structures have performed very well in some settings. The major problem is basket failure, a problem that is aggravated by ice and other debris, gravel bedload movement, vandalism, and corrosive streamflows. Gabions are usually cost prohibitive when compared to riprap structures, but instances may occur when they are a preferred alternative. Stacked gabions are prone to slumping from undermining at the toe, flanking and deformation due to failure of the wire baskets. Although gabions are not a preferred method of riverbank stabilization in CVNP, there will continue to be a need for these structures. One improvement that can be made to these features is to set the lowest row of the gabion system on a designed riprap toe that provides an erosion resistant foundation. Another is to install brush layers between the rows of baskets to establish woody vegetation that will increase the stability and longevity of the gabion structures, while enhancing habitat and aesthetics.

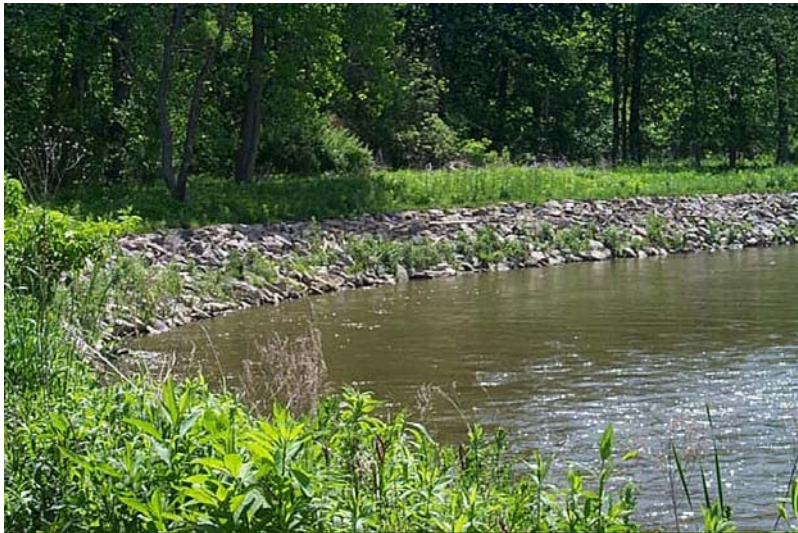
Figure I-12. Continuous Riprap Toe Without Vegetative Plantings Above at CVNP.

A continuous riprap toe repair, shown in Figure I-12, has been utilized in a number of locations adjacent to the Towpath Trail and Valley Railway. These types of repairs are subject to undermining at the toe and flanking, therefore they will need to be repaired or extended from time to time. These types of features can be improved by limiting the height of the riprap to an elevation no greater than the dominant discharge, and possibly as low as the mean discharge if shear stresses are low, and providing vegetation in the form of brush layers, live stakes, and Vegetation Reinforced Soil System (VRSS) above the top of riprap.

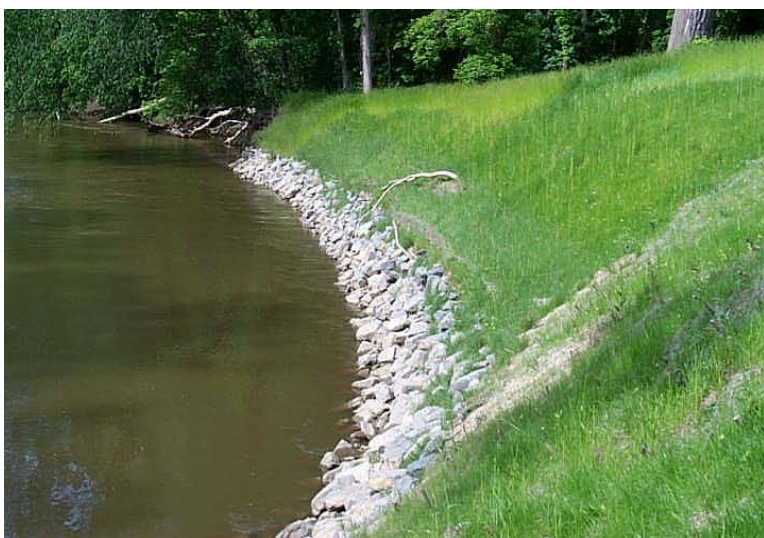
**Figure I-13. Continuous Riprap Toe With Vegetation
Above Top of Riprap at CVNP.**

A continuous riprap toe repair with vegetative plantings, shown in Figure I-13, has been utilized in a number of locations primarily adjacent to the Towpath Trail. These types of repairs are also subject to undermining at the toe and flanking, therefore they will need to be repaired or extended from time to time. The riprap in these features has typically been designed to an elevation no greater than the dominant discharge, and possibly as low as the mean discharge where shear stresses are low. One significant improvement to these features can be made by providing additional riprap in the form of a launched stone toe where toe scour is anticipated. Another is the provision of hardier vegetation in the form of live stakes, brush layers and VRSS above the top of riprap. Improvements in the hardiness of vegetation can be made by improving the quality control in connection with harvesting, storage, and installation of live, dormant plant material.

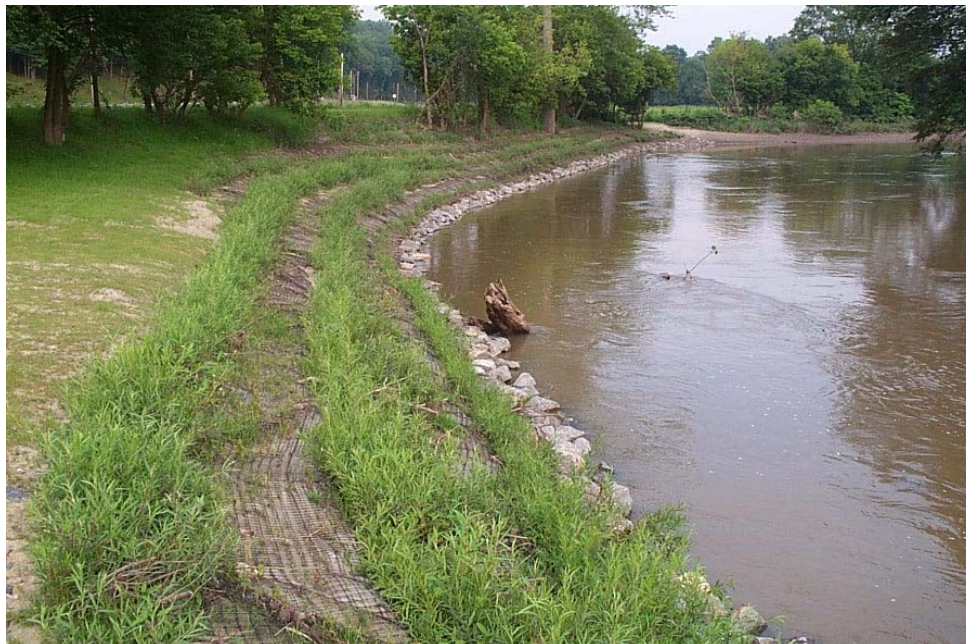
Figure I-15. Vegetation Reinforced Soil System (VRSS) 6 months after construction at CVNP

Cuyahoga Valley National Park has utilized several combinations of a riprap toe and bioengineering measures above. Figures I-14 and I-15 show the typical section and photograph of the Vegetation Soil Reinforced System (VRSS). The VRSS is useful for the reconstruction of steep fill slopes. It is a complex method that requires a team with extensive knowledge and understanding of site assessment (specifically geotechnical and hydrological factors), reasons for use, and methods of installation to ensure immediate and long-term success in developing functionality. Similar to brushlayer fill, it involves the cutting and placement of live rooted plants or live branch cuttings in regular arrays in the face of a reconstructed slope. The branches or items are oriented perpendicular to the slope. This orientation, along with the addition of geogrid, offers significant reinforcement to the soil mantle. The geogrid is both used within the fill as well as wrapped around the face of each soil lift. It is a method that is useful for upland slopes, stream and riverbanks as well as shoreline areas, to solve more complex, deeper instability as well as higher velocity conditions. The VRSS consists of placing grid and branches on prepared lifts of soil. The soil lifts between the branches are wrapped with grid. The contribution of branches and grid offer immediate soil reinforcement to the newly constructed slope. The protecting branches assist in retarding runoff and surface erosion, as well as reducing velocities from flowing water. The installed branches are intended to grow, producing roots and leaves. The same type of design can be accomplished using live stakes, live posts, live fascines or brush layering.

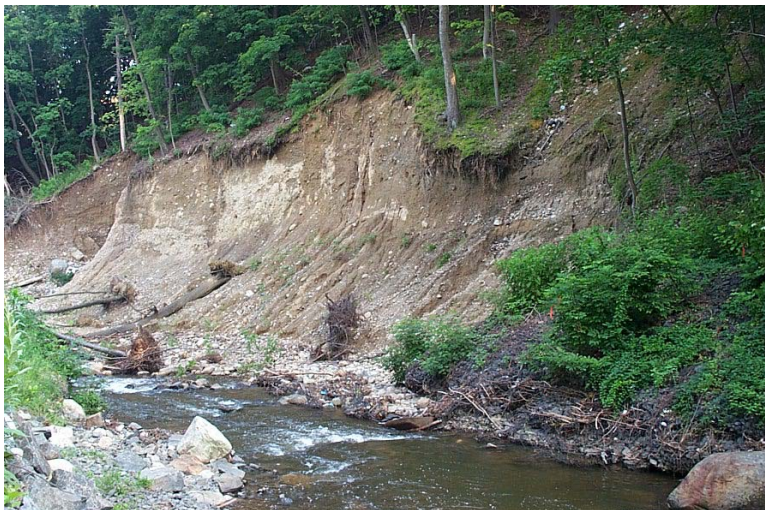
Figure I-20. Bank Failure Needing Mechanical Stabilization.

Slope failures caused by fluvial erosion adjacent to steep banks, similar to that shown in Figure I-20 require repair of the eroded slope adjacent to watercourses. To repair the slope and maintain the stream invert, often requires mechanical stabilization of the slope at a steeper angle than can be maintained in nature without deep rooted vegetation. For situations such as this, a geosynthetic reinforced soil embankment, cellular confinement embankment, shown in Figure I-21, or other mechanical stabilization method repair is needed. In Figure I-21, the mechanically stabilized slope can be constructed to a 1.5H:1V slope. A turf reinforcement matting is used on the slope to provide a protected surface for establishment of turf
